DEPARTMENT OF TRANSPORTATION**DIVISION OF ENGINEERING SERVICES**

Contract #: 04-0120F4Cty: SF/ALA Rte: 80 PM: 13.2/13.9File #: 69.28**WELDING INSPECTION REPORT****Resident Engineer:** Pursell, Gary**Address:** 333 Burma Road**City:** Oakland, CA 94607**Report No:** WIR-014267**Date Inspected:** 22-May-2010**Project Name:** SAS Superstructure**OSM Arrival Time:** 700**Prime Contractor:** American Bridge/Fluor Enterprises, a JV**OSM Departure Time:** 1500**Contractor:** Zhenhua Port Machinery Company, Ltd (ZPMC), Changxing Island **Location:** Shanghai, China**CWI Name:** Li Jia**CWI Present:** Yes No**Inspected CWI report:** Yes No N/A**Rod Oven in Use:** Yes No N/A**Electrode to specification:** Yes No N/A**Weld Procedures Followed:** Yes No N/A**Qualified Welders:** Yes No N/A**Verified Joint Fit-up:** Yes No N/A**Approved Drawings:** Yes No N/A**Approved WPS:** Yes No N/A**Delayed / Cancelled:** Yes No N/A**Bridge No:** 34-0006**Component:** Orthotropic Box Girder (OBG) components**Summary of Items Observed:**

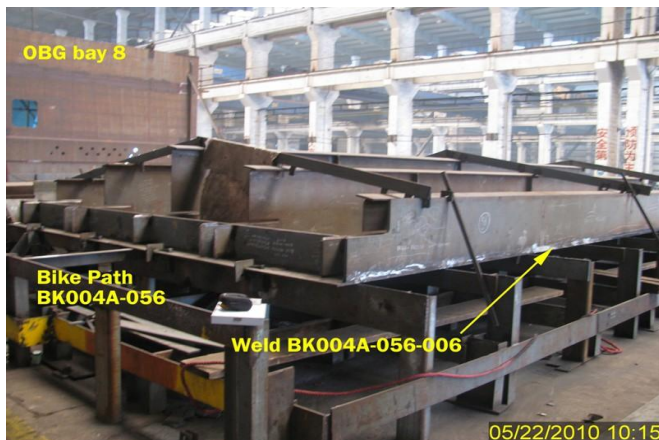
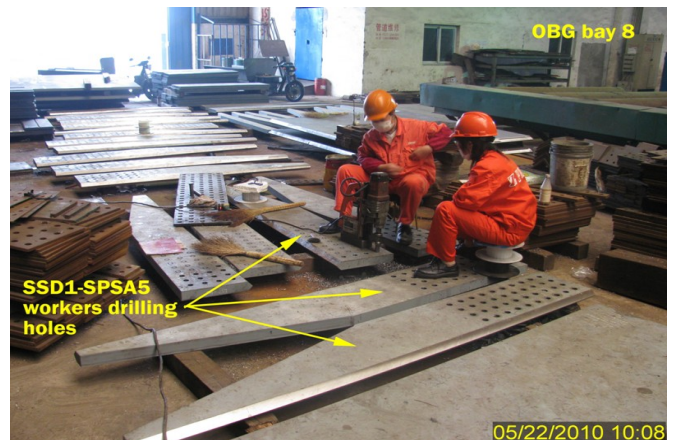
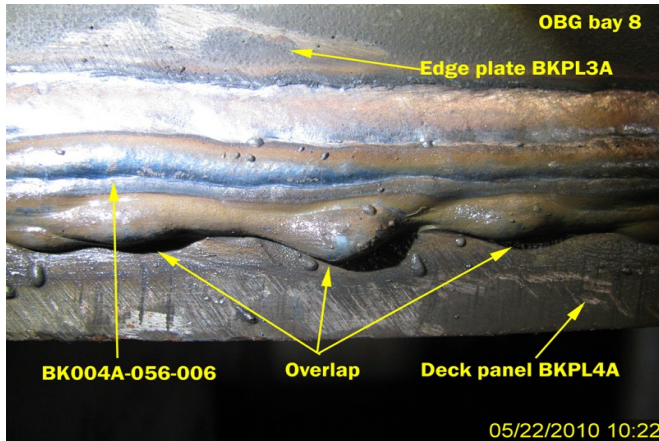
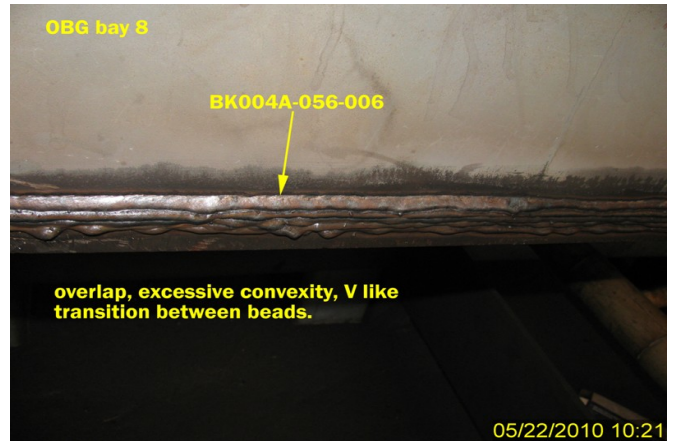
This QA observed bike path segment identified as BK004A-056 is partially fit and welded in this bay. During random in process Visual Testing (VT) of some of the welds on this bike path, this QA observed the weld profile of weld identified as BK004A-056-006 does not appear to meet the quality requirements of AWS D1.5 2002. QA noted that ZPMC is still in process of grinding and repairing this weld. QA observed no work was being performed on this bike path during the time QA was present. See attached pictures for details of the weld profile issues on the above mentioned weld.
